Case Study: Cenicerros Whole House Performance Retrofit

The home

- Built: 1998
- 2 stories
- 2850 ft²
- Slab on grade
- 30% more efficient than Title 24 (SMUD Advantage Home)

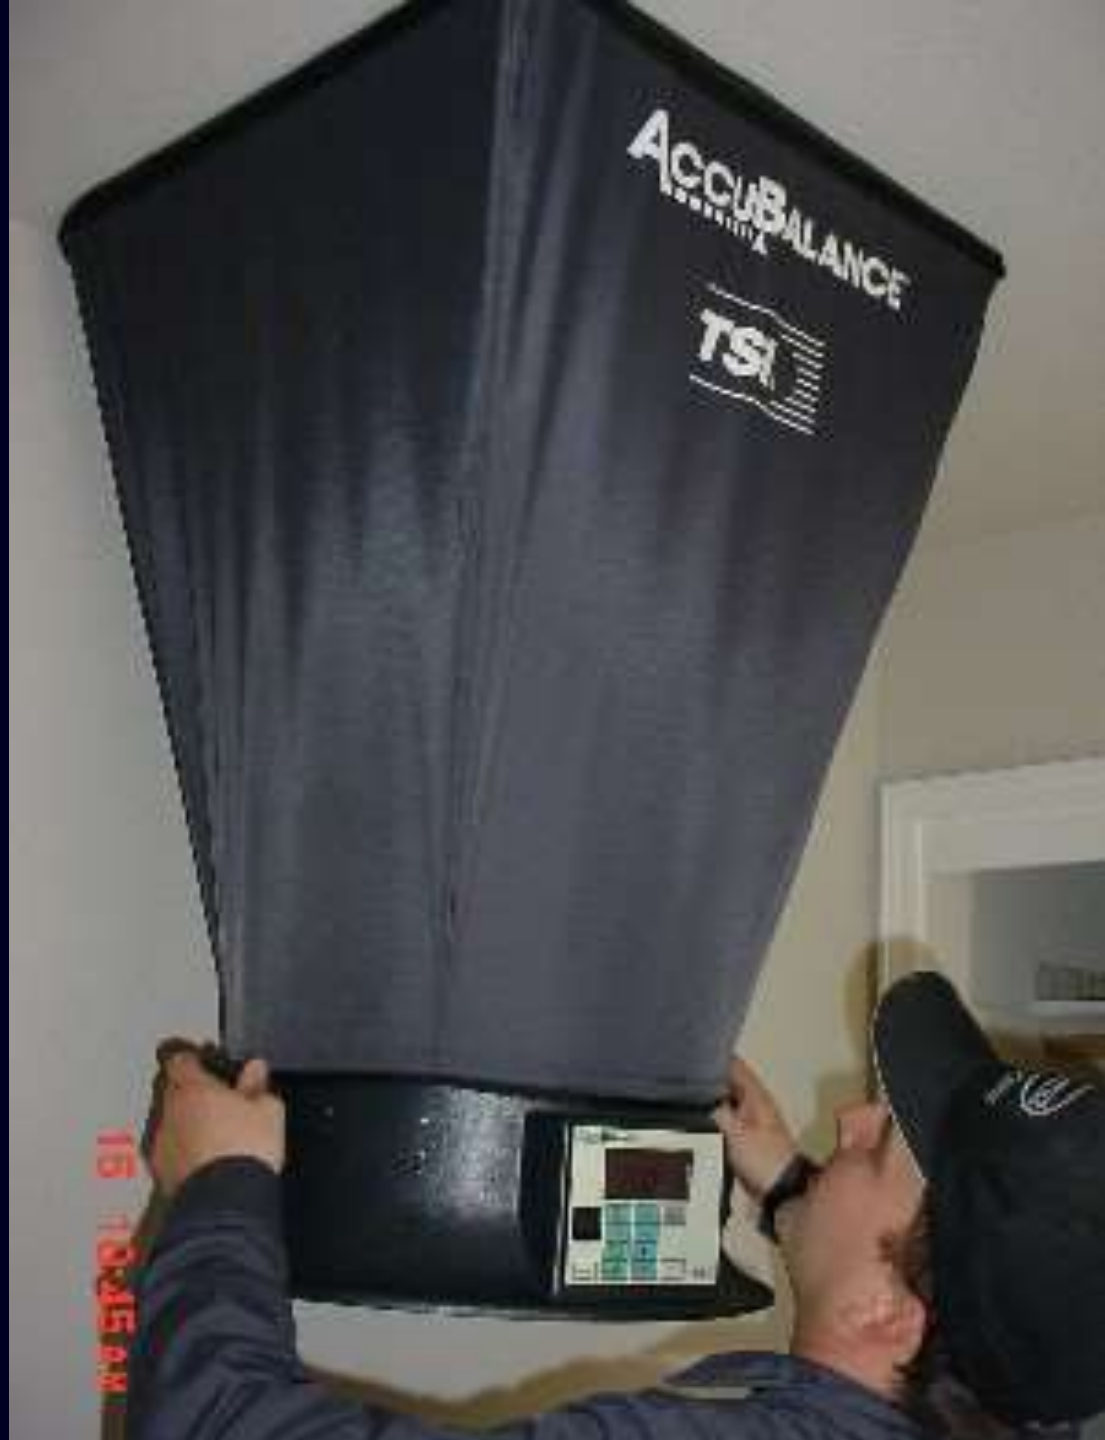
Flow hood
measures air
flow from
each register

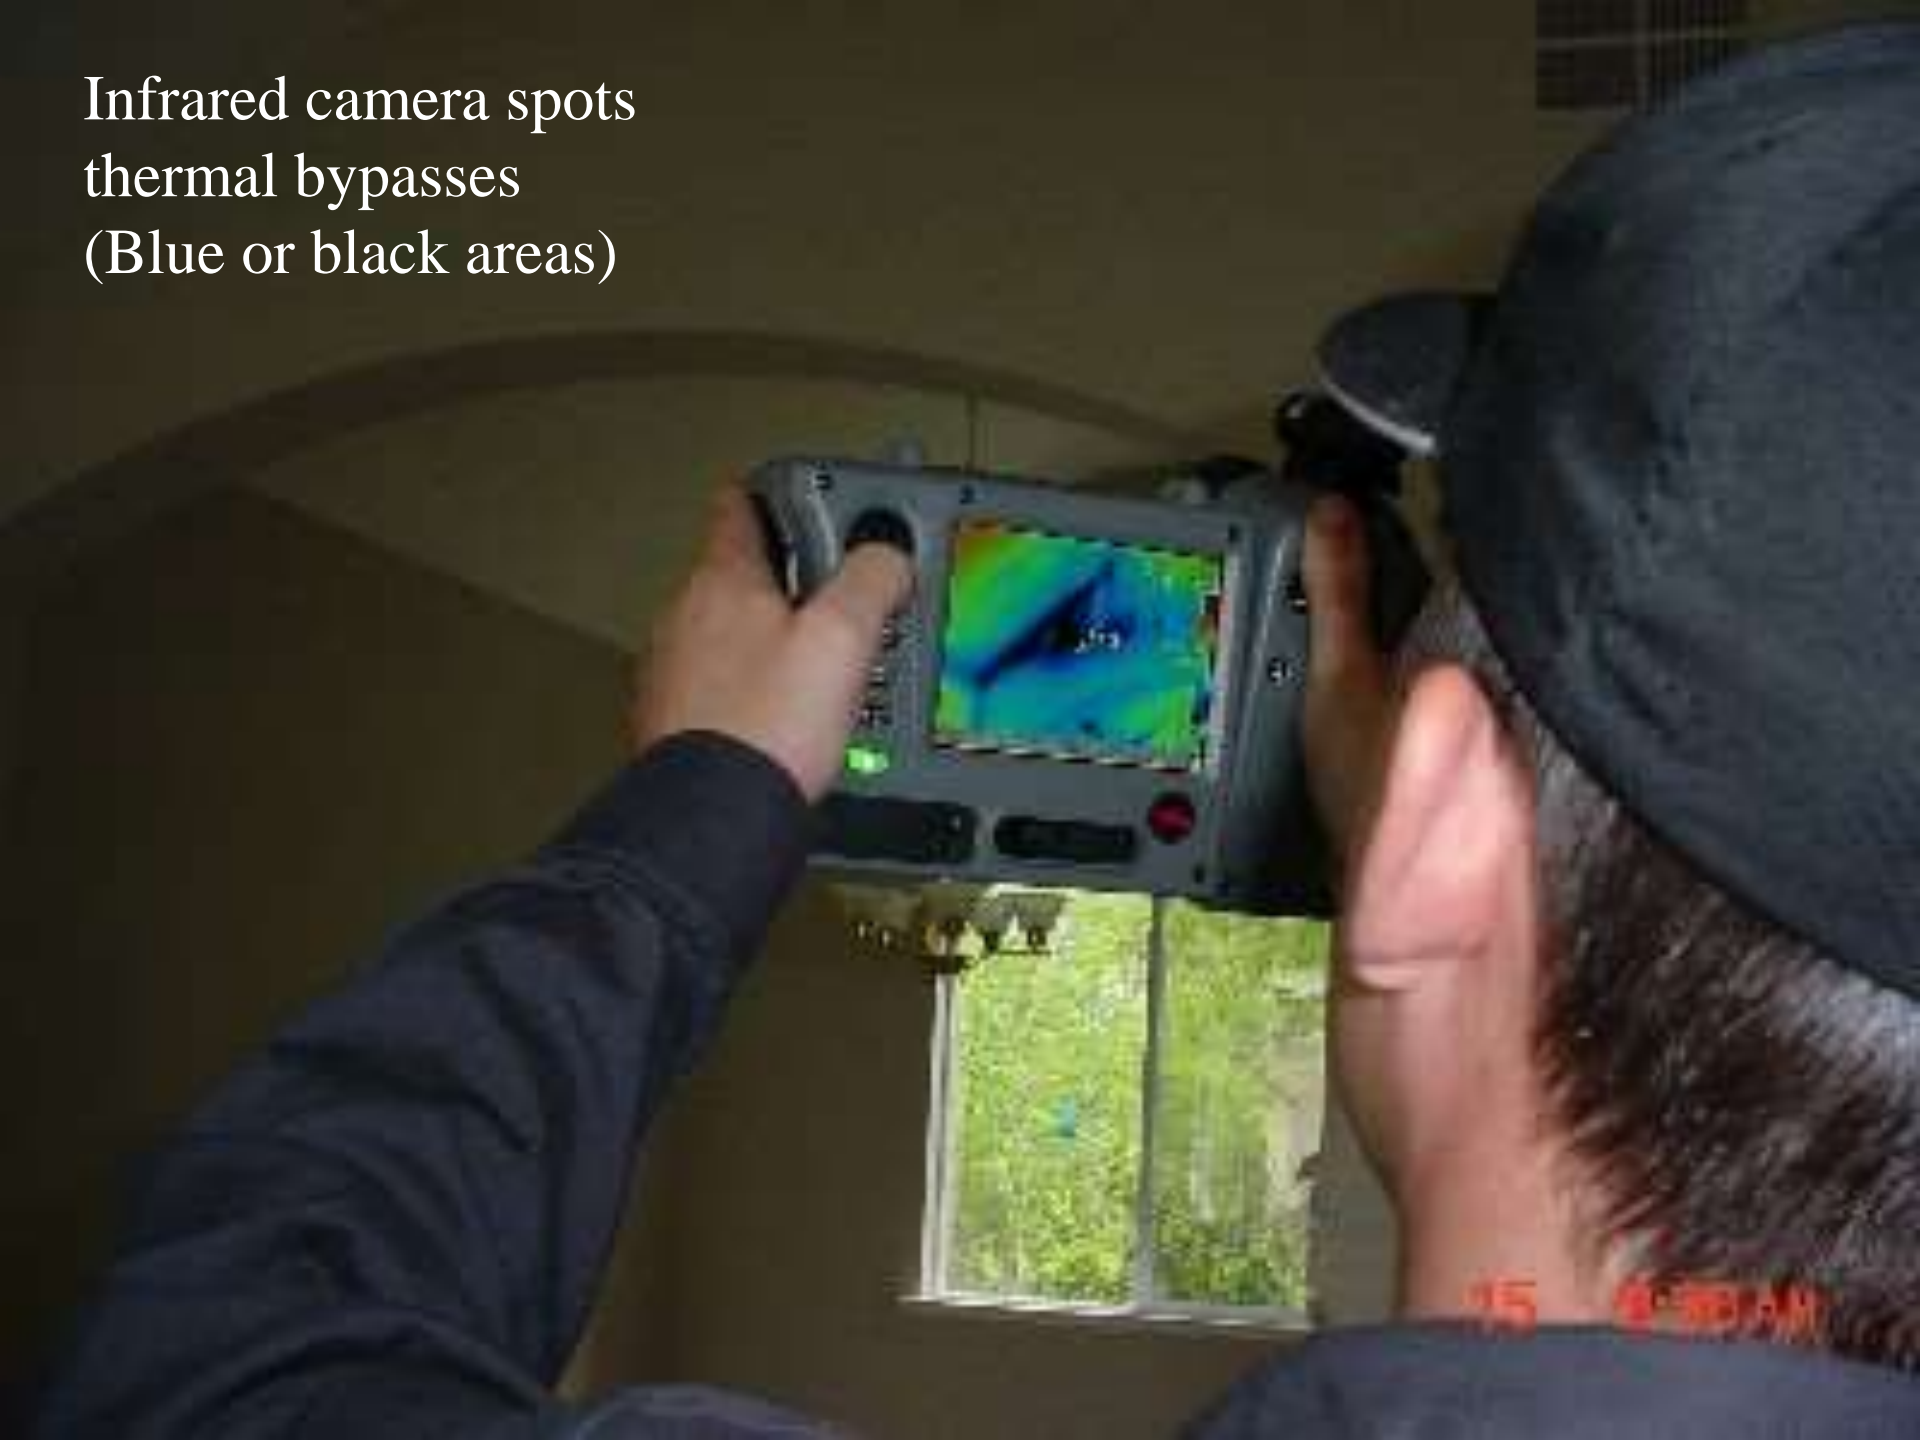
Infrared camera spots
thermal bypasses
(Blue or black areas)

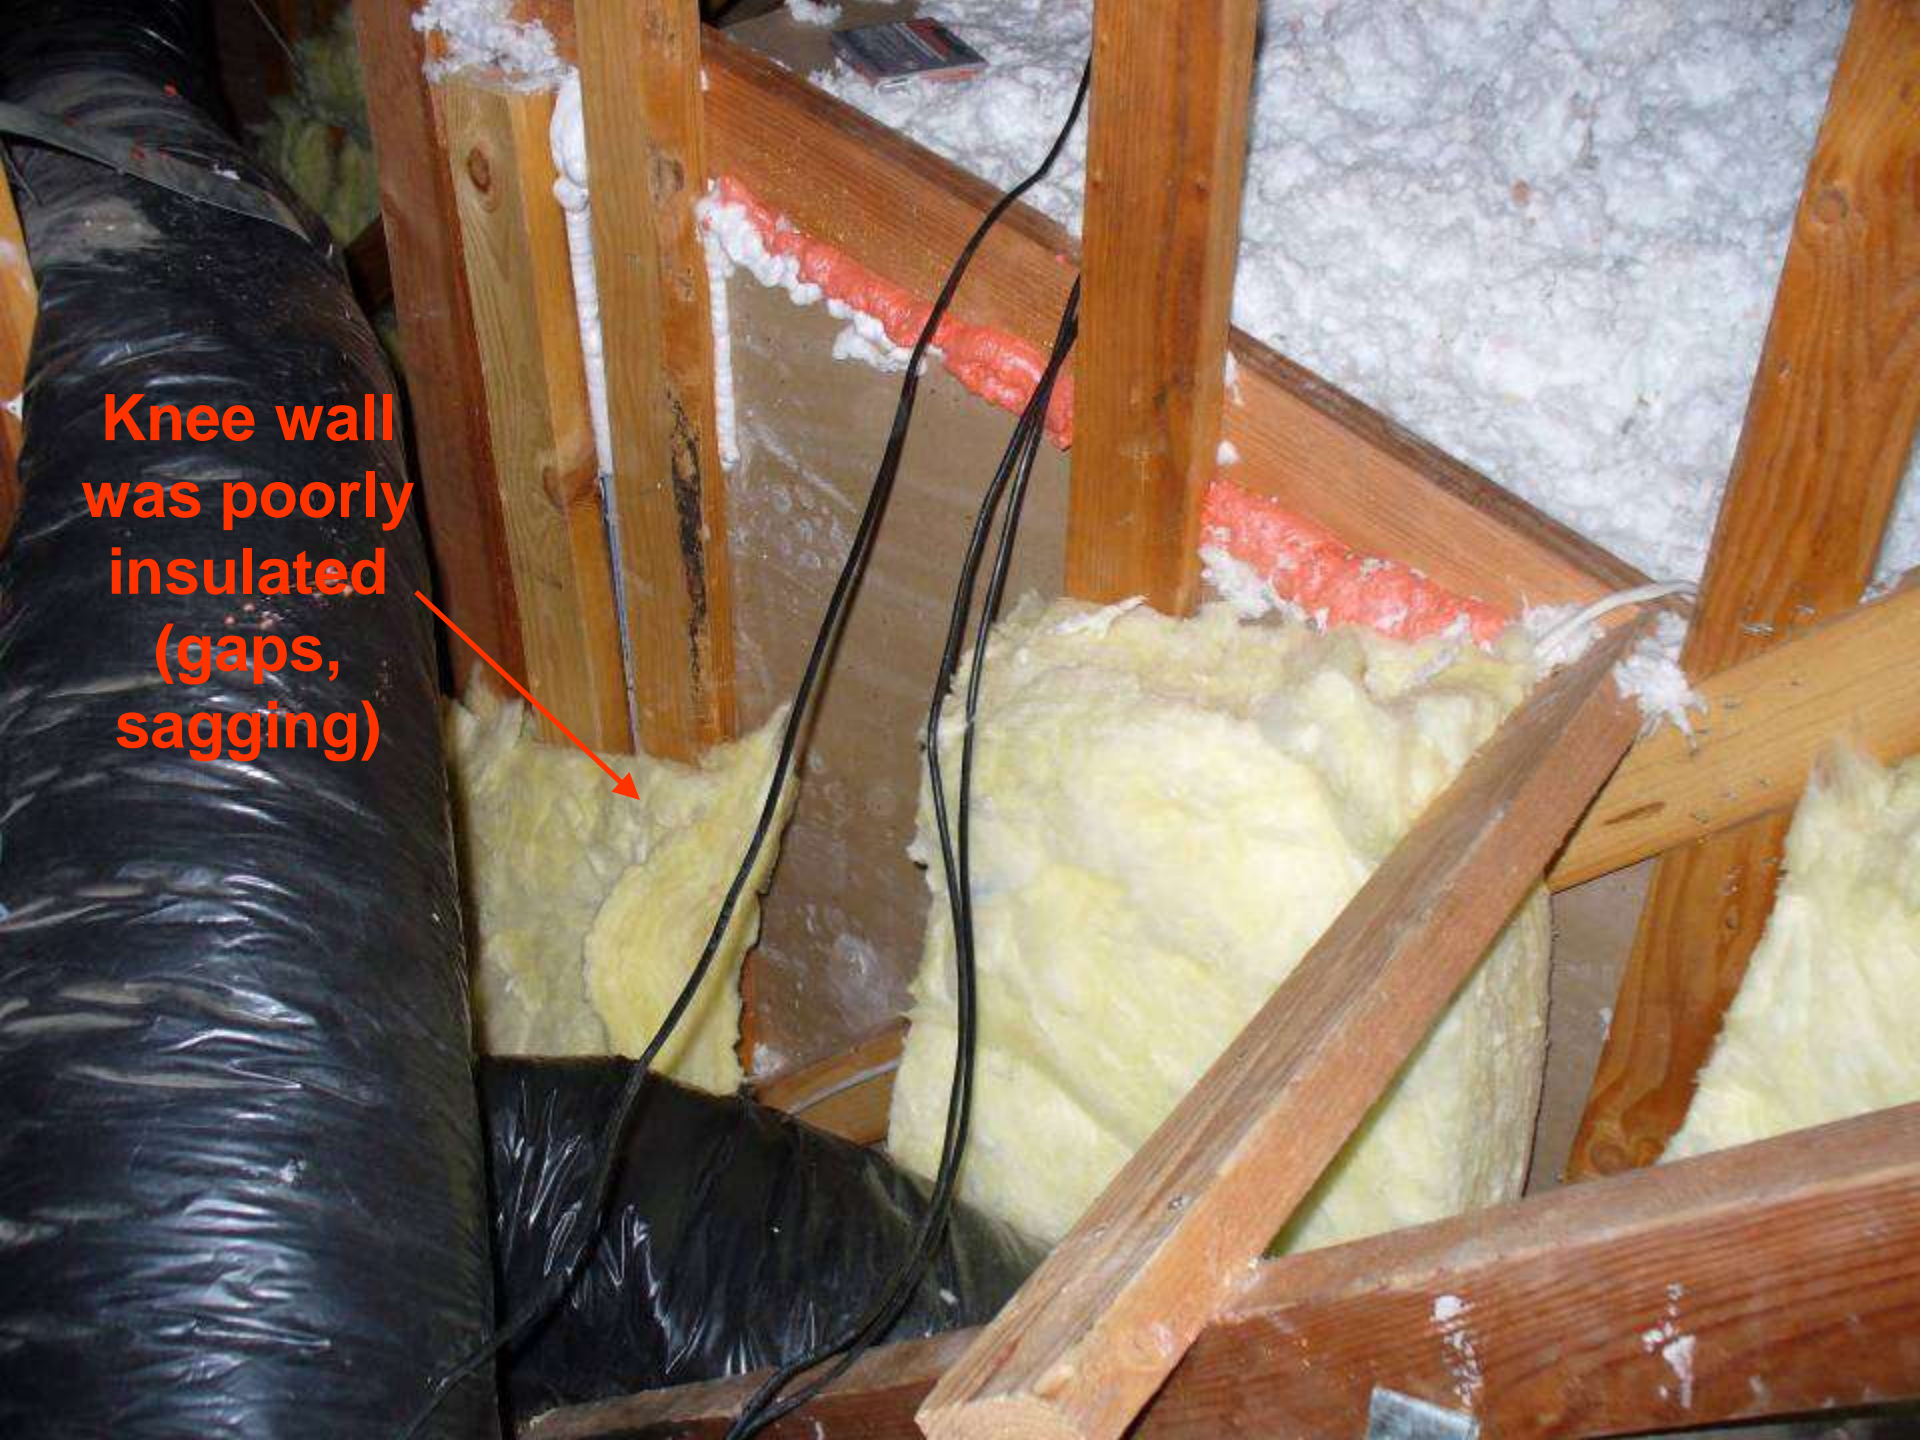
**Knee wall
was poorly
insulated
(gaps,
sagging)**

- Repair thermal bypasses
- Insulate knee-walls properly
- Insulate floor assembly between garage and upstairs bedroom
- Seal envelope to achieve minimum desired natural air changes (to 1200 cfm₅₀)
- Seal ducts to less than 3% leakage
- Install additional return in master bedroom
- Install balancing dampers and perform air balance

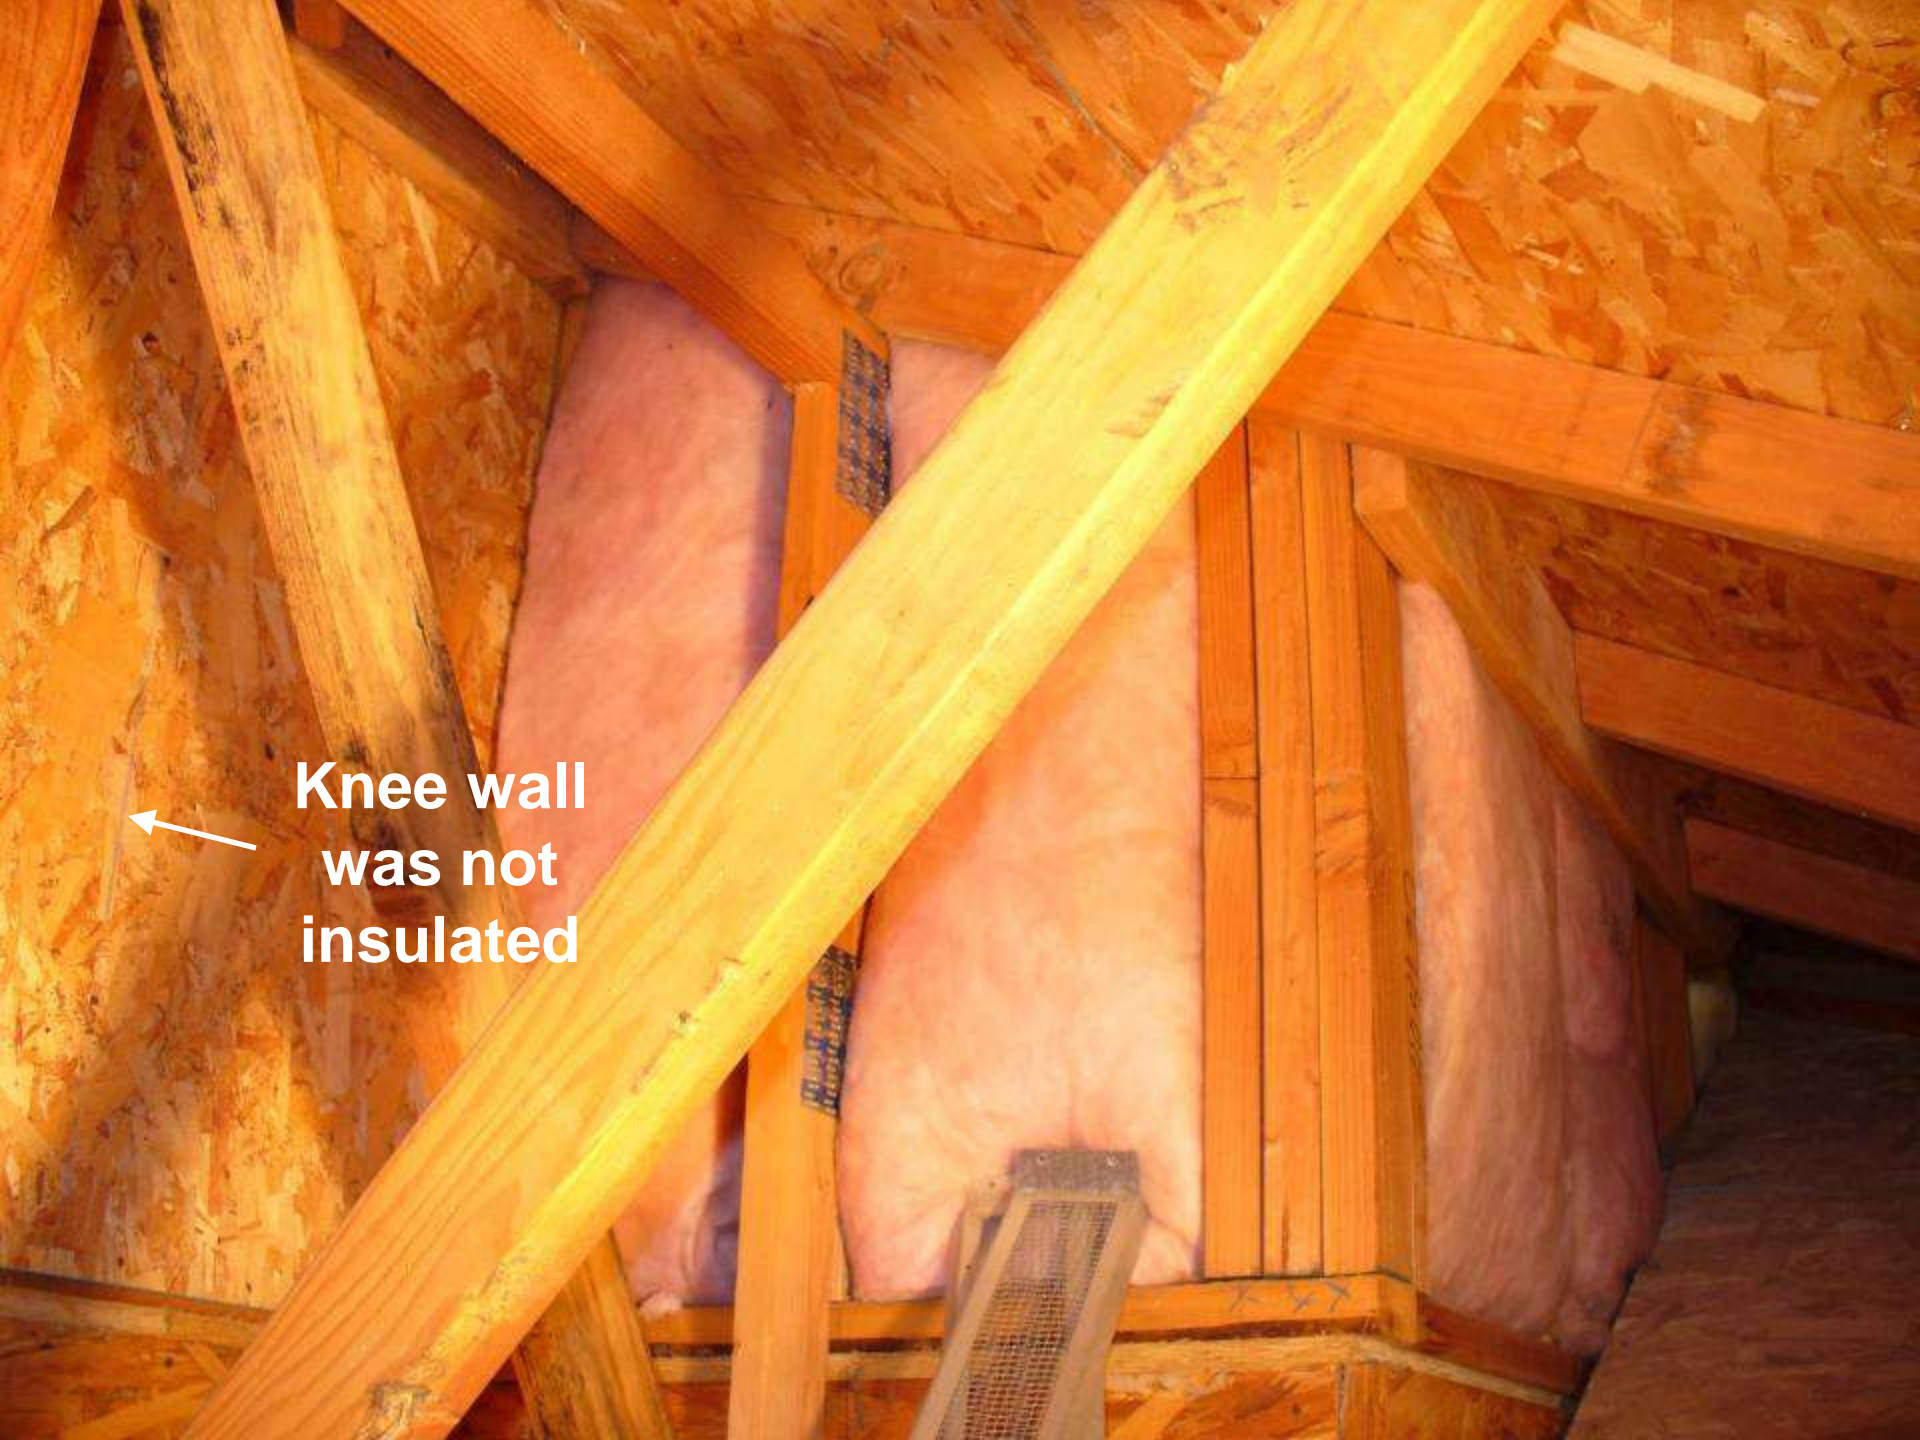
**Knee wall
was not
insulated**

- Reconfigure ducts to allow burying in insulation
- Install engineered and re-sized return grills to achieve better mixing and reduce noise
- Provide return air paths from bedrooms
- Install knee wall dams and re-insulate attic to R-38
- Right-size AC and furnace
- Perform test-out to confirm performance (including combustion appliance safety testing)

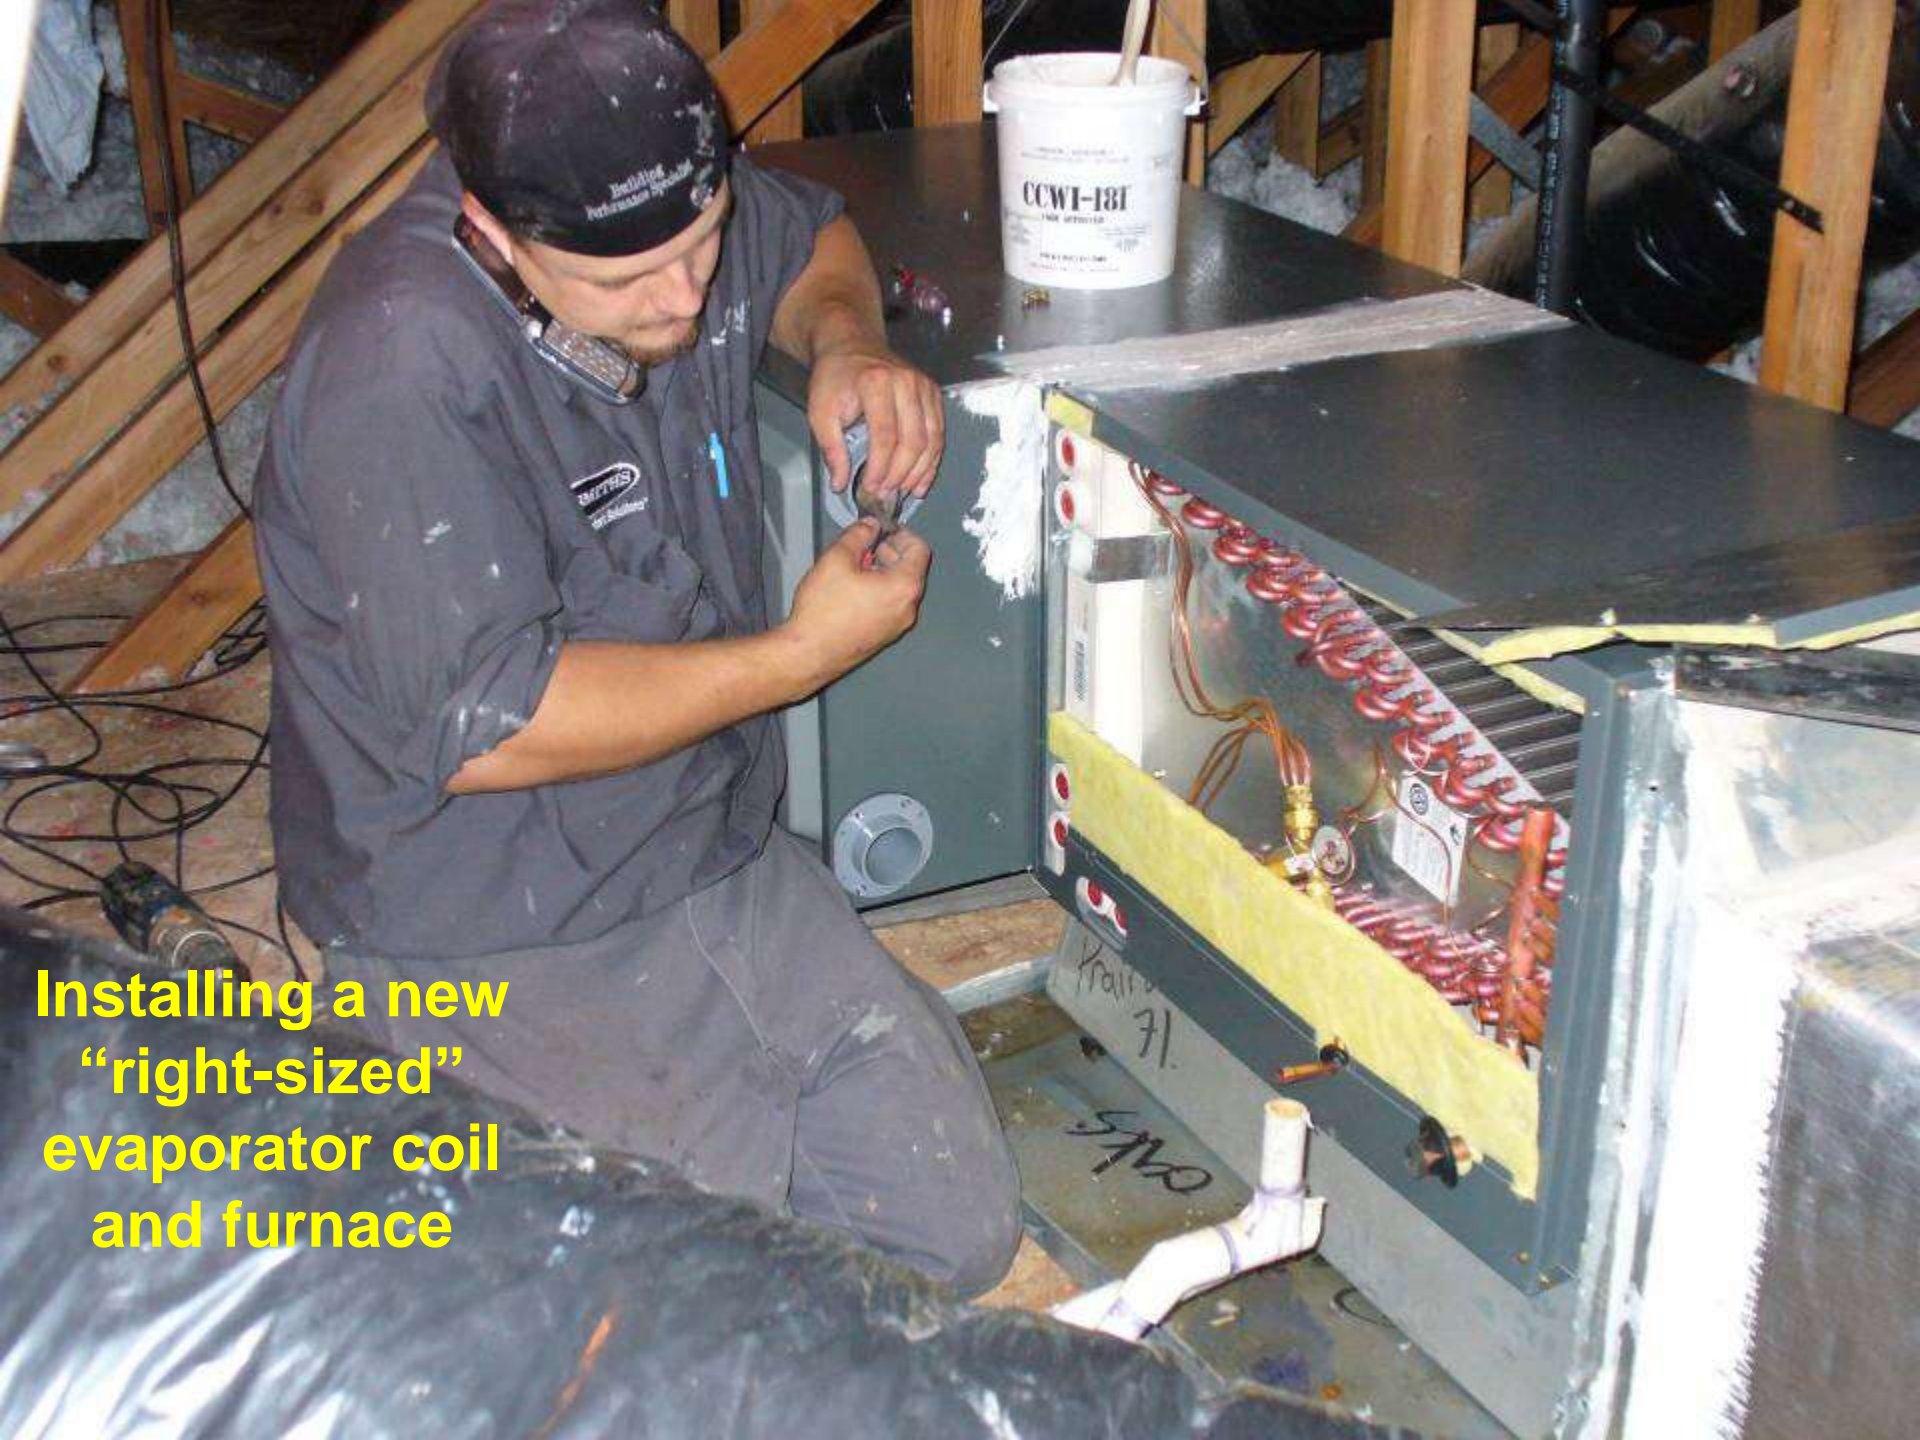
Installing a new
“right-sized”
evaporator coil
and furnace

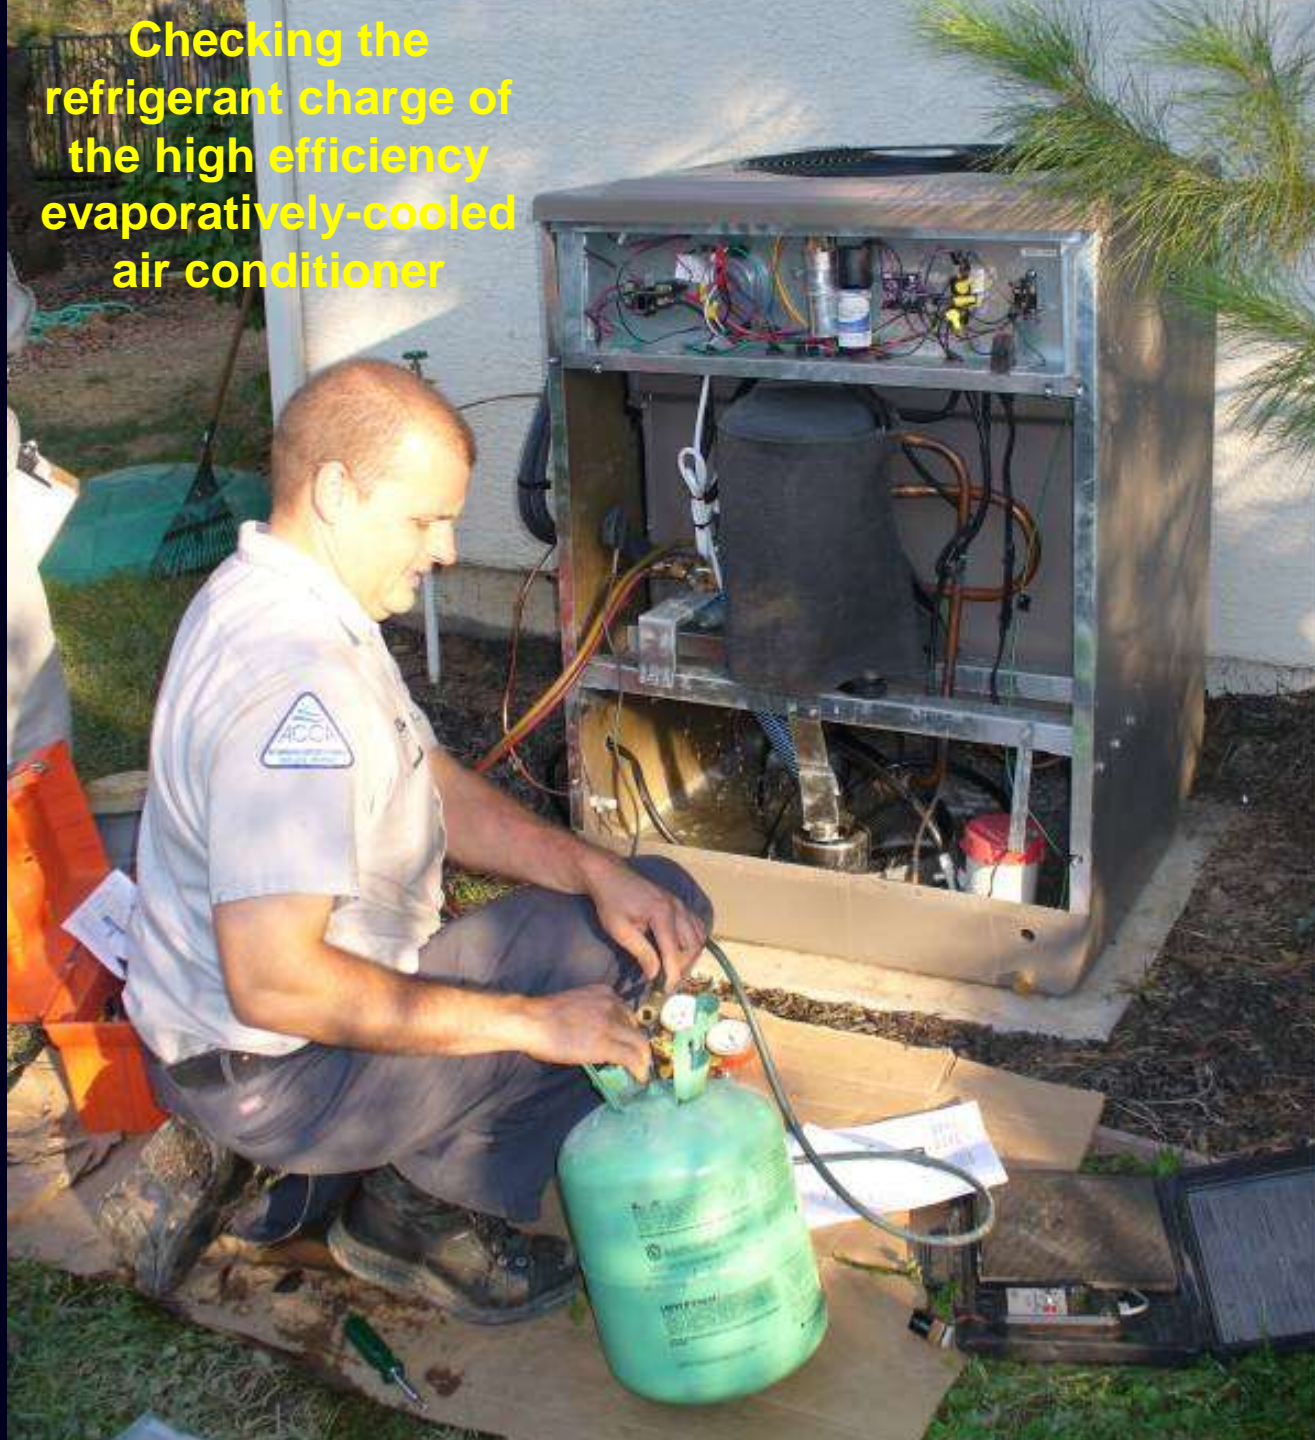
**Checking the
refrigerant charge of
the high efficiency
evaporatively-cooled
air conditioner**

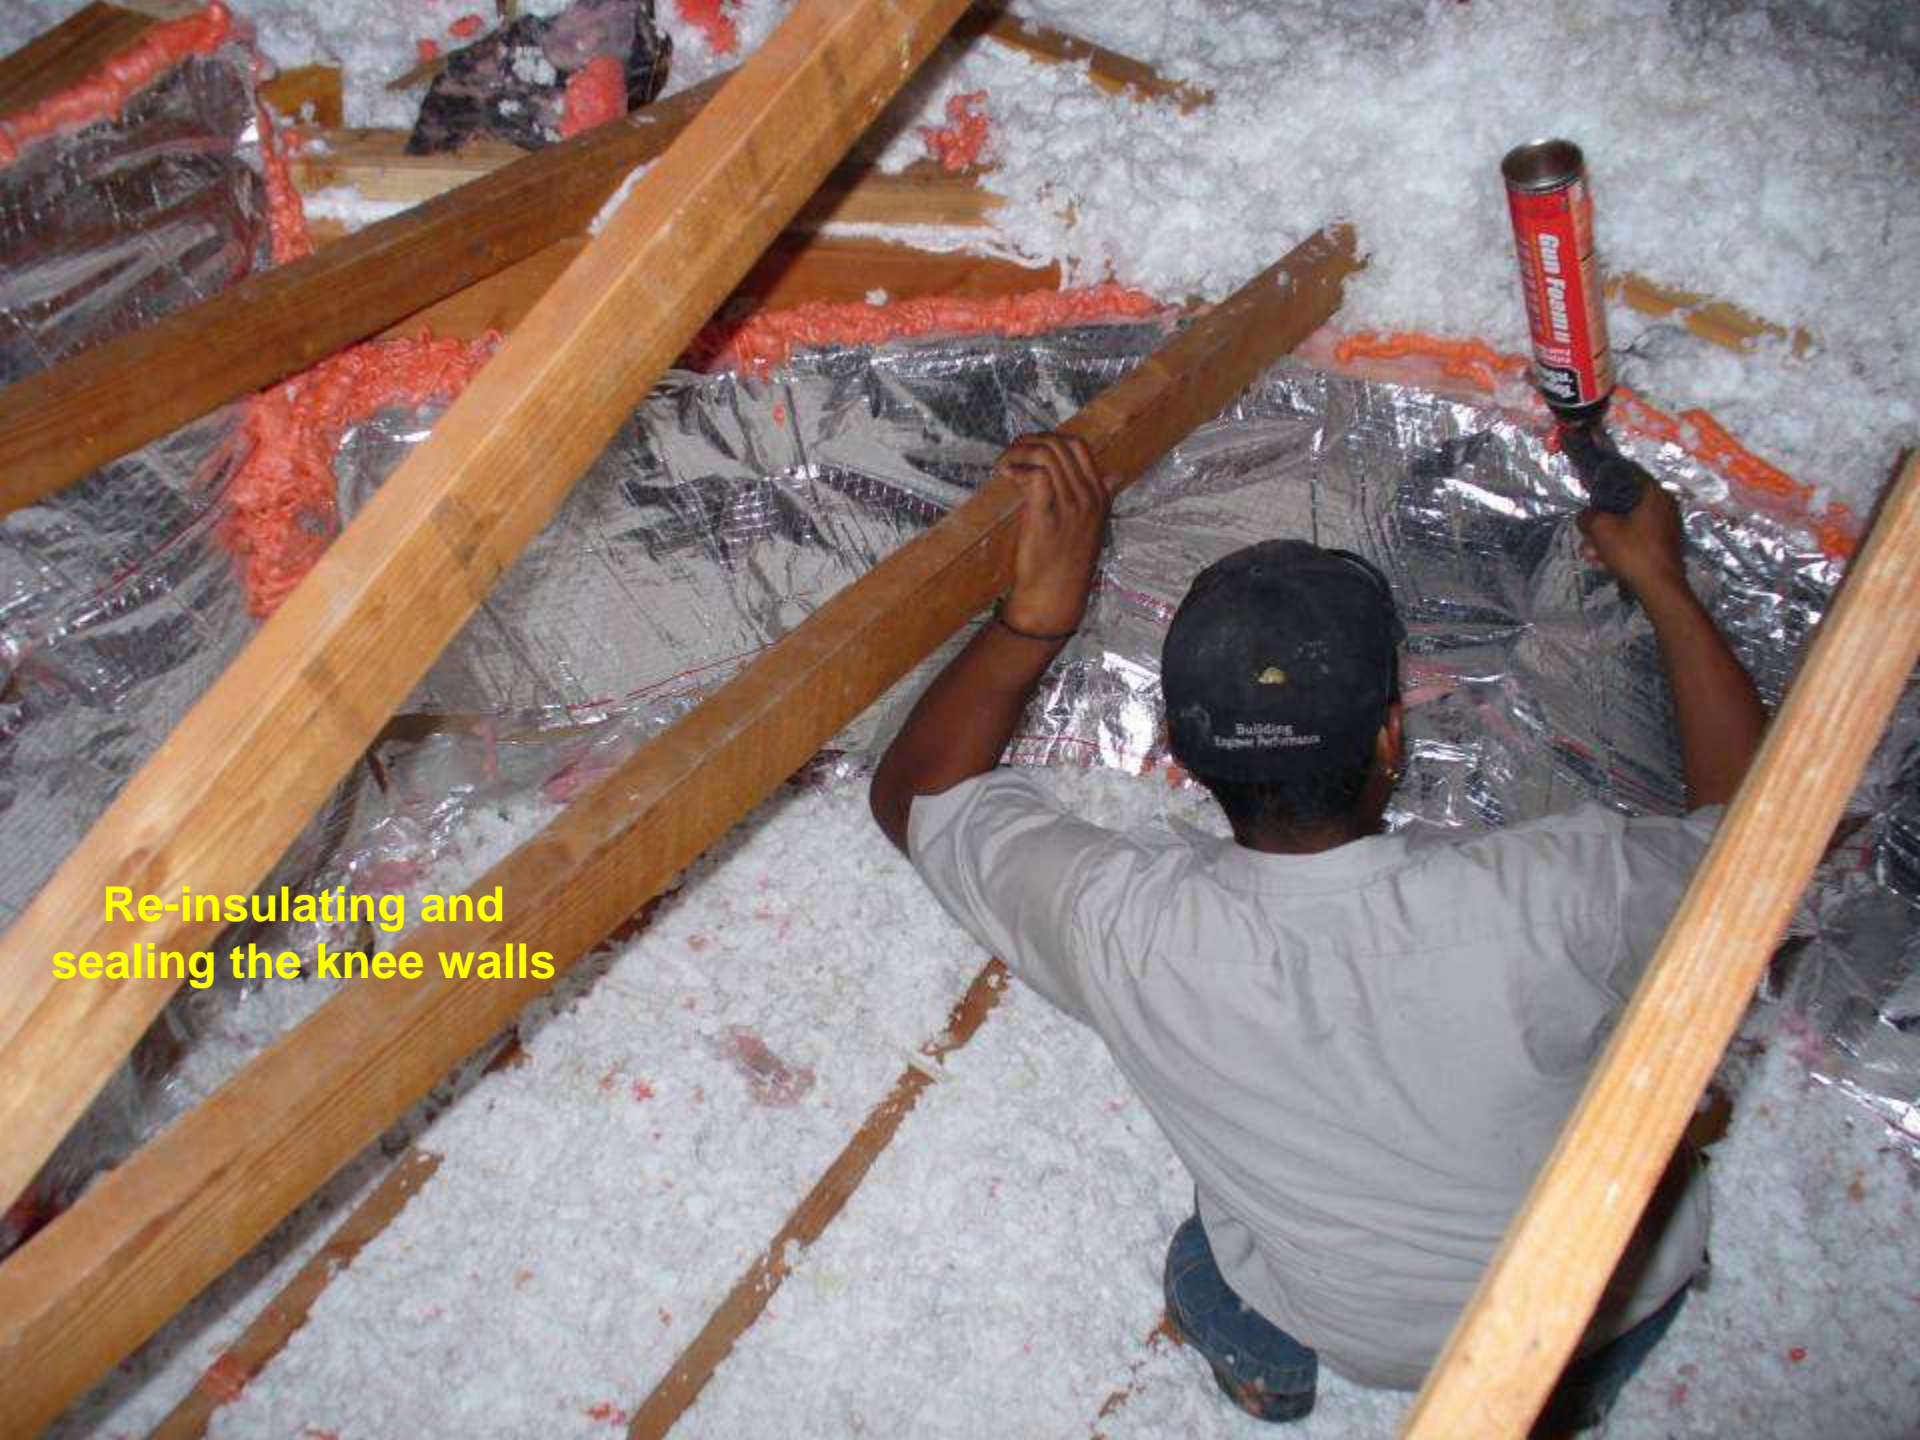
Re-insulating and
sealing the knee walls

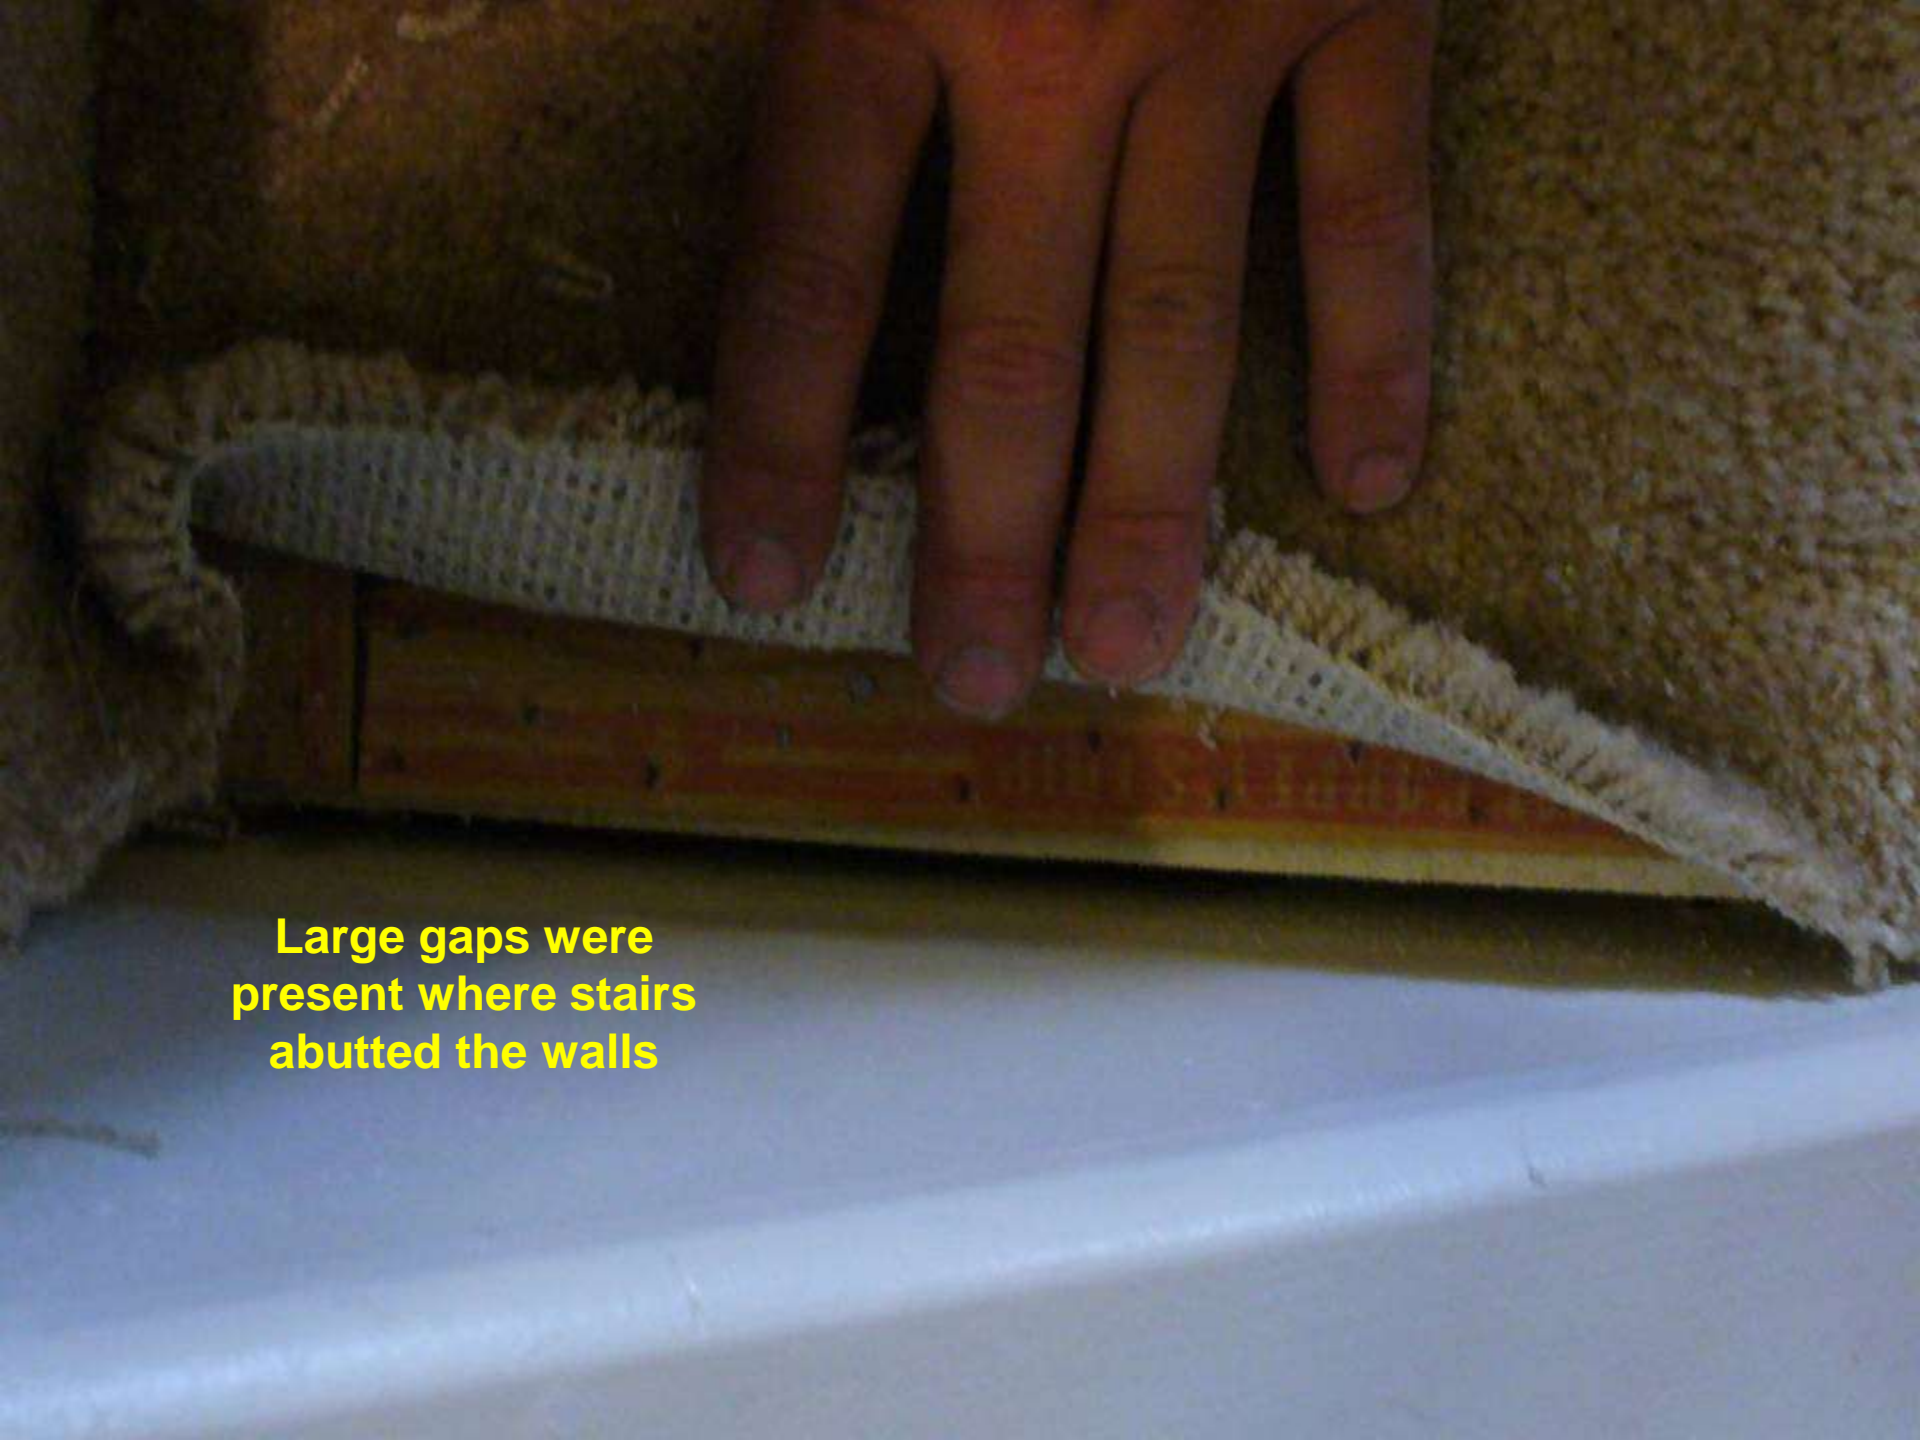
A close-up photograph showing a person's hand lifting a beige carpet. The carpet is being pulled back to reveal a wooden floor board underneath. There is a significant gap between the carpet and the wall on the left side. The wooden board has some red paint or staining on it. The overall scene suggests a renovation or inspection of a staircase area.

Large gaps were
present where stairs
abutted the walls

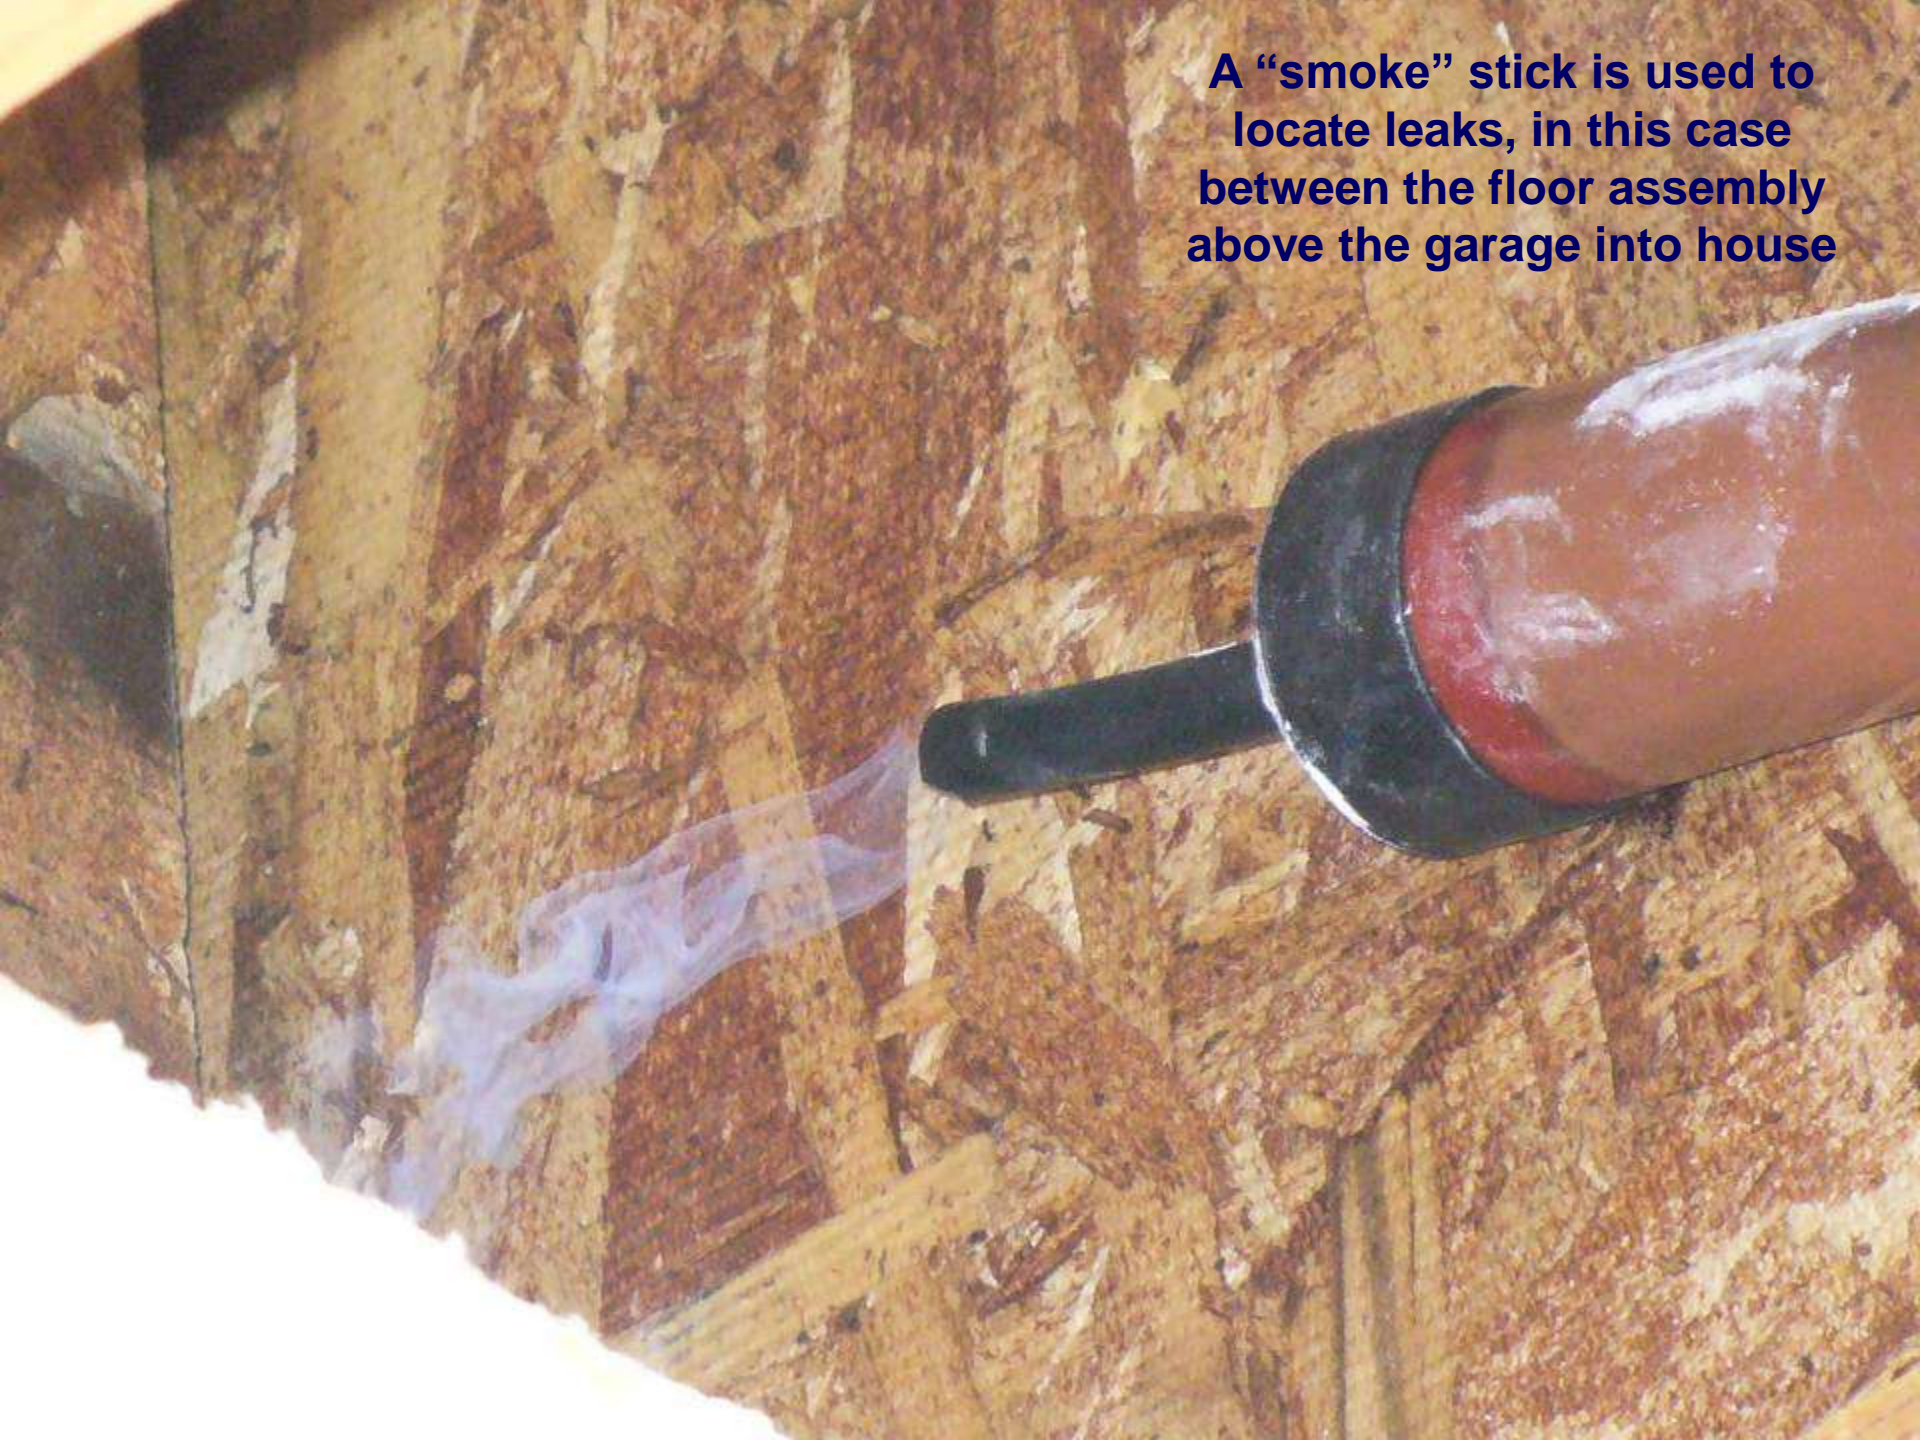
A “smoke” stick is used to locate leaks, in this case between the floor assembly above the garage into house
