Case Study: Cenicerros Whole House Performance Retrofit

The home

- Built: 1998
- 2 stories
- 2850 ft²
- Slab on grade
- 30% more efficient than Title 24 (SMUD Advantage Home)

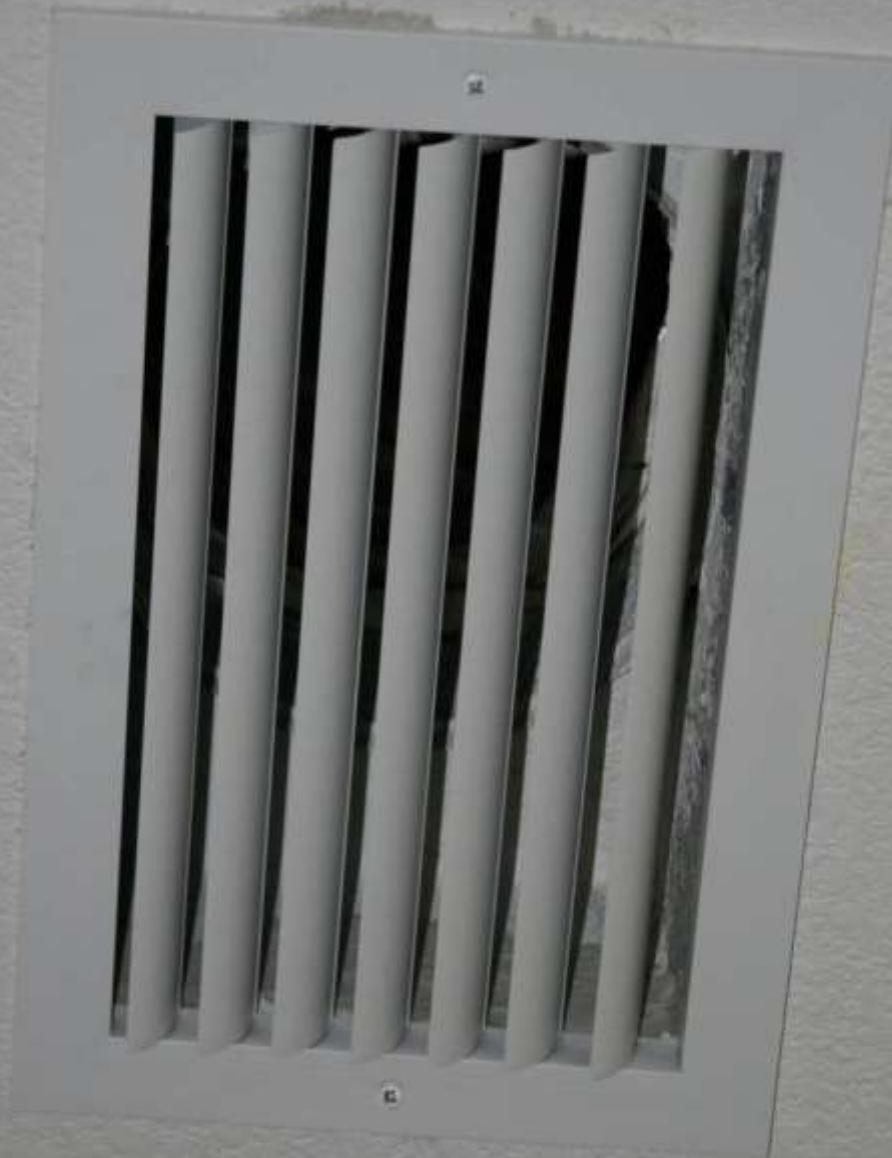
Engineered supply grilles resized for proper velocity and throw at design air flow

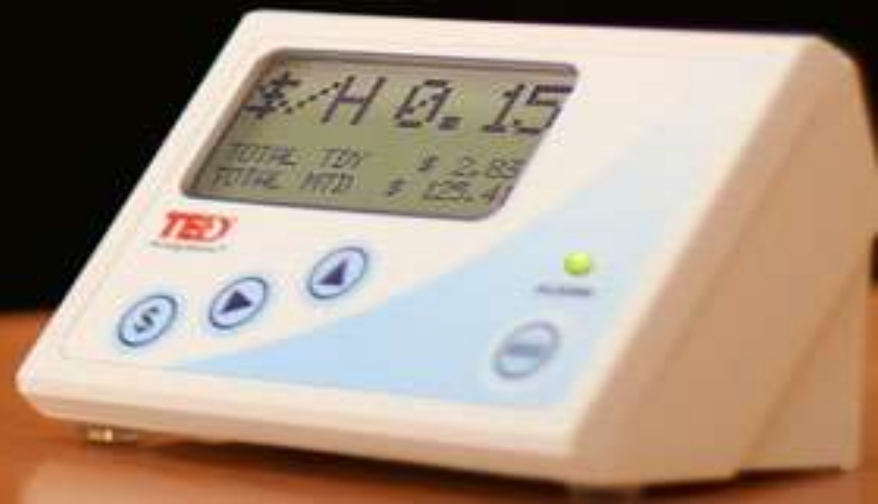
In-home energy display
